**Basic Energy Audit Report- Clipstone Village Hall**

*Produced by NEP Energy Services Ltd*

<b>Site Name</b>	<b>Clipstone Village Hall</b>
Site Address	90 Church Road Clipstone Mansfield NG21 9DL
Site Contact	Michelle Paxton
Date of Audit	30 <sup>th</sup> April 2024

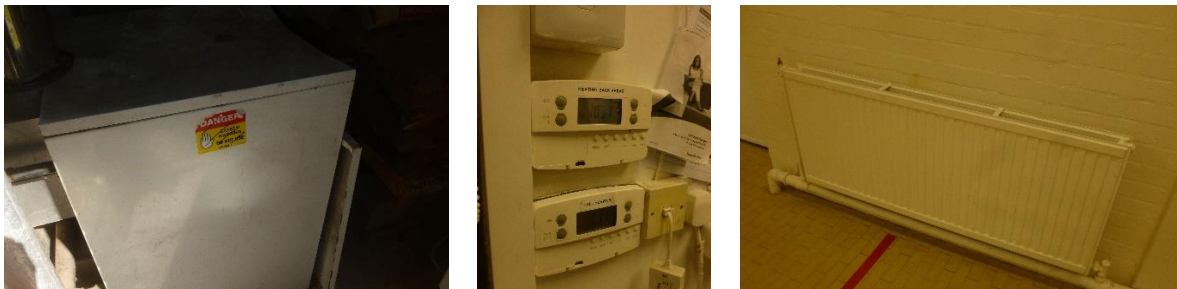
- The building is heated by a non-condensing conventional gas-fired boiler with a rated efficiency of 79% as-built (given the age of the unit the efficiency is likely to be lower than this) serving a wet central heating system; heating is emitted via radiators, some of which are damaged.

- The heating system has two independent zones; one serving the hall and the other serving the offices and toilets.
- The system is thermostatically controlled via programmers for each zone at suitable temperatures – these are manually adjusted in the hall according to what activity is taking place; this is mostly done by staff members but some hall users are given control of the heating if using the hall into the evening. These programmers are tricky to operate and regularly need re-setting.

Figure 1 HVAC equipment (left to right) – ageing non-condensing boiler; heating system programmers are not fit for purpose; radiators in some cases are damaged

The heating system is presently controlled by programmers which are temperamental and difficult to operate; the timers and thermostats frequently need adjusting for the hall depending upon how it is used (*i.e.* some hall bookings are active classes so require a lower heating demand) – in some instances hall users are given control of the heating system and there have been cases where heating has accidentally been left on overnight.

Upgrading the heating controls can save as much as 10% on gas consumption; but just as importantly in this situation is having controls that are easier to use and that can be used remotely via apps, allowing part time staff to operate the heating system without having to be in the building at late hours.

Advanced heating controls include optimum start/stop and weather compensators to reduce the amount of time that the heating needs to be on by ‘learning’ how quickly the building (and its zones) heats up and cools down in relation to outdoor ambient temperatures. A Building Management System (BMS) can also incorporate a booking system whereby temperature settings are automatically adjusted according to what group activity/hall usage is taking place, reducing having to manually alter temperatures every week (or more frequently if late bookings/changes occur).

The boiler is ageing and is running at lower efficiencies than newer condensing models offer and as a result will be using more energy and costing more to run.

A gas-fired conventional condensing boiler (note a combi boiler would not necessarily be suitable given the hot water demand and the supply issues as highlighted previously) would be cheaper than a heat pump and provide greater financial savings based on current energy prices. A heat pump would provide greater carbon and energy savings but would not produce an annual financial saving because of the switch of fuel from relatively cheap gas to more expensive electricity, even taking the improvement in efficiency of a heat pump system. The savings in Table 2 are based on replacing the existing system with a conventional condensing gas-fired boiler, efficiency 95% (note savings do not take additional savings such as ongoing maintenance and lifetime cycle analysis into account).

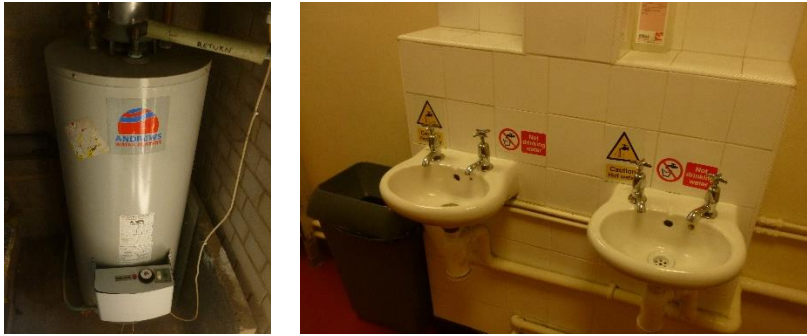
- Domestic hot water is provided by a well insulated hot water cylinder; the cylinder is an older model with high standing losses and struggles to meet demand sufficiently, particularly towards the end of its run.
- Taps are fitted with standard fixtures with no water-saving devices in place.

Figure 2 HWS equipment (left to right) – hot water heater struggles to meet demand; taps are not fitted with water saving devices

The current gas-fired hot water system is not fit for purpose; return flow temperatures regularly struggle to reach the recommended 60°C required to avoid legionella issues and water points at the furthest end of the building (end of the run) take a long time to get suitably warm enough, wasting water and energy as a result. The system is ageing too so is likely to have a lower efficiency than when new, costing more to run.

The system could be replaced with a like-for-like gas-fired option with a higher efficiency and better pumps, however this may not necessarily solve the supply issues and could become more expensive to resolve. A more practical and cost-effective solution would be to remove the current system and replace with local stand-alone electric water heaters. These would have far shorter runs so would

Many of the fixtures around the buildings are outdated and using more water and energy to heat that water.

Replace taps, particularly to the hot flow, with aerated fittings and/or with push-stop fittings to reduce the amount of water being supplied to the user. Sensors can also be fitted as a more sophisticated measure. For the hot flow tap this will also reduce energy consumption as less water has to be heated. Costs include installing a matching cold water tap for aesthetics and water saving.

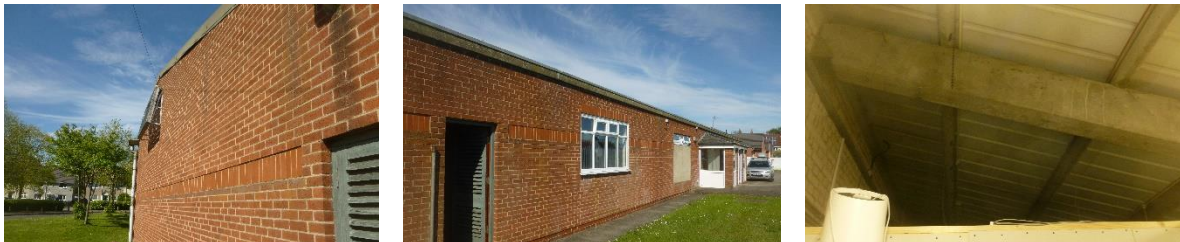
- The building was originally constructed c.1960s with solid brick walls and profiled pitched roof; the original building comprised the hall only and was extended (date unknown but assumed to be of the same decade) to include the office section with cavity brick walls – the roof was extended over this section. The original walls had a cavity brick slip pattern applied to uniform the building (no cavity between the internal solid brick and external slip).
- The solid walls and cavity walls are uninsulated, as is the roof space. The offices have a tiled suspended ceiling above which has been insulated in places but does not appear to have full coverage.
- Windows are fitted with uPVC-framed double glazing with thermally-improved spacers.

Figure 3 Building fabric (left to right) – cavity brick slips applied to original walls; cavity wall construction on frontage; underside of metal roof, no insulation as-built or above suspended ceiling

The offices have a suspended ceiling above them which has insulation above in places but does not appear to cover the entire area, as a result there will be significant rates of heat loss through the ceiling to the uninsulated roof above (approximately 25% of heat loss is through the roof), increasing heating demand in winter and cooling demand in summer.

Installing insulation above the office suspended ceiling grid would be a more cost effective option than insulating (or most likely, replacing) the roof itself. Insulative 600x600mm bags can be placed directly on top of the ceiling grid to reduce heat loss and heat demand.

The rear of the property has solid walls which will be expensive to insulate with very long paybacks, however the front of the building (the office side) has a cavity wall structure which, given its age and lack of retrofit evidence, is highly likely to be uninsulated. Given that approximately a third of heat loss in buildings is via the external walls, insulating these (or as much as practically possible), is highly recommended to reduce heat loss and demand.

Cavity wall insulation has low levels of disruption and can usually be completed within a day, compared with more expensive measures such as solid wall insulation. Solid wall insulation is worth considering for the rest of the building if budgets allow, however priority should be given to the walls that can be insulated more easily.

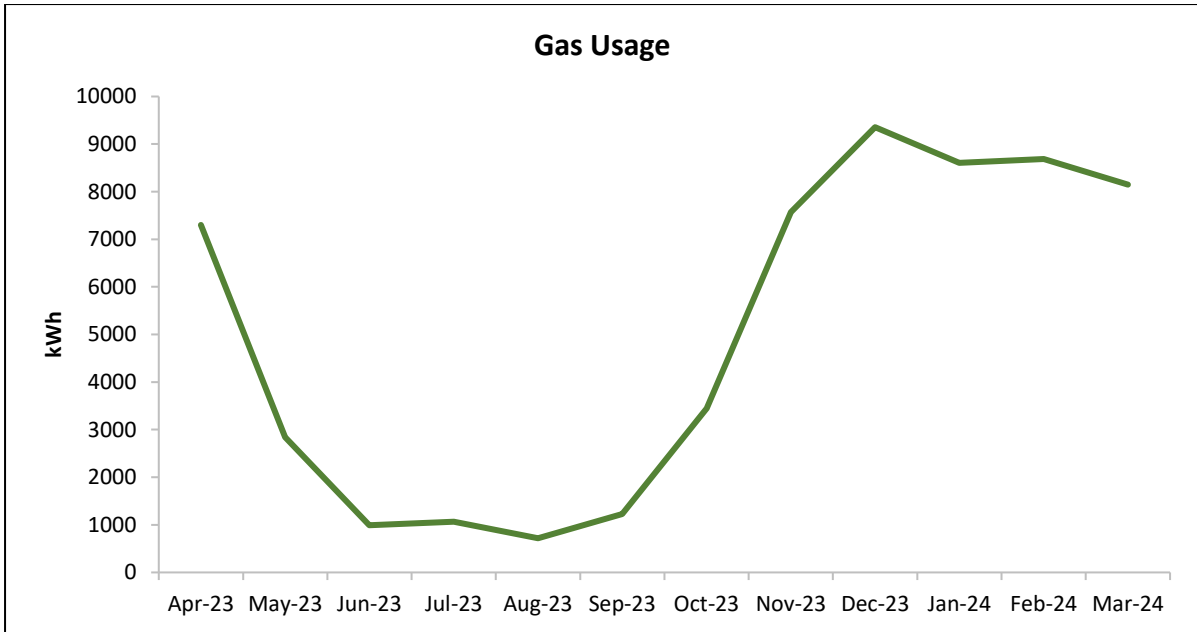
Figure 5 Gas consumption profile

The gas consumption profile in Figure 5 is indicative of a building using gas for heating; consumption peaks in winter when demand increases and drops in summer when demand is at its lowest. The consumption in summer is most likely attributed to hot water consumption.

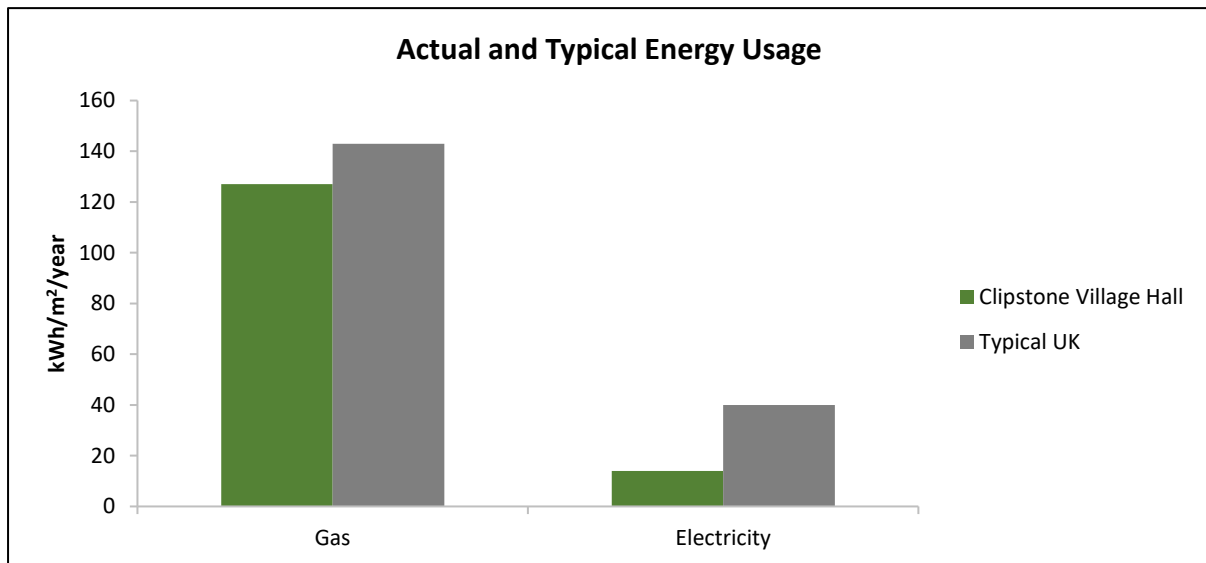
Figure 7 Benchmark comparisons

Figure 7 compares this building's annual energy usage with a 'Typical' benchmark, set by CIBSE, of the same building category. The building uses less kWh/m<sup>2</sup>/year of gas and electricity compared to a building of this type in the UK, especially electricity.
